HEADQUARTERS STRATEGIC AIR COMMAND
DIRECTORATE OF AIRCRAFT MAINTENANCE
AIRCRAFT ENGINEERING DIVISION
(Hq SAC/LGME)

ENGINEERING REPORT NO. P-206

TF30-P-7 INSTALLED TRIM CORRECTION

14 January 1977

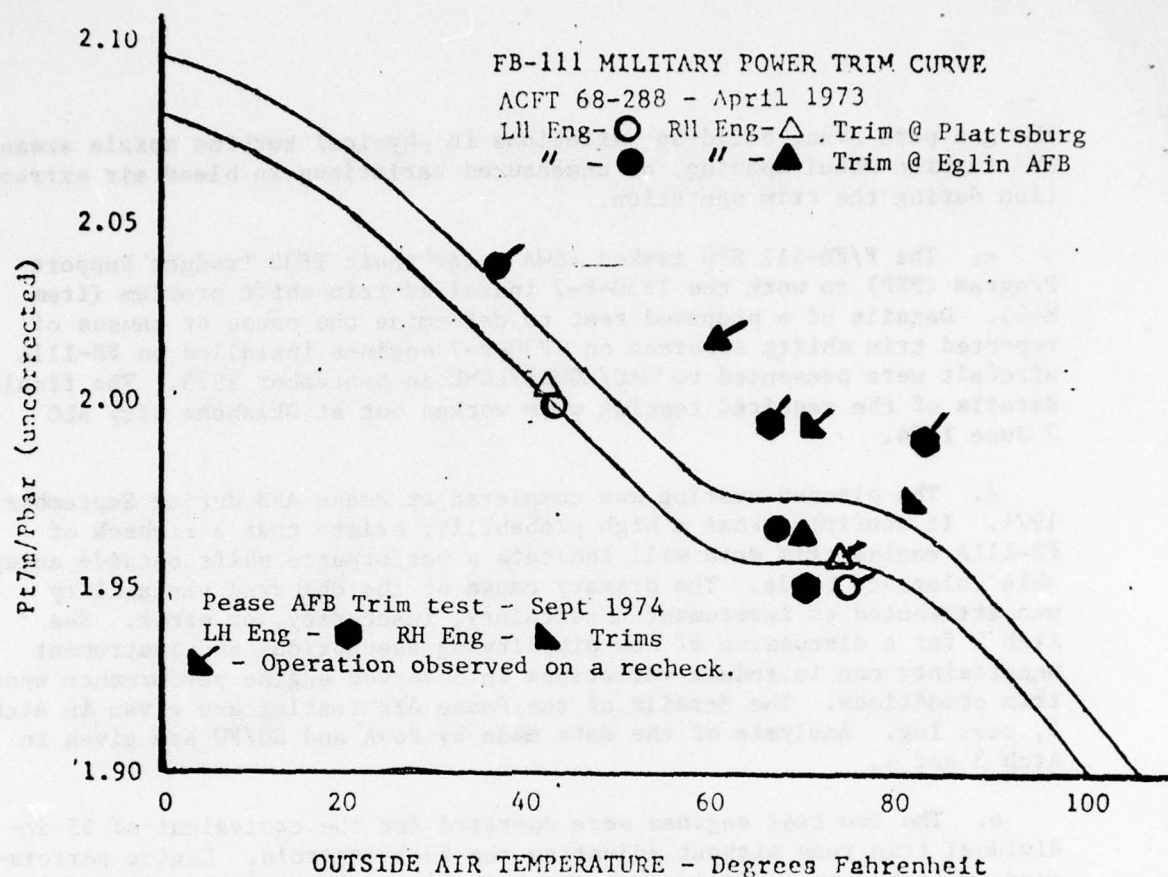
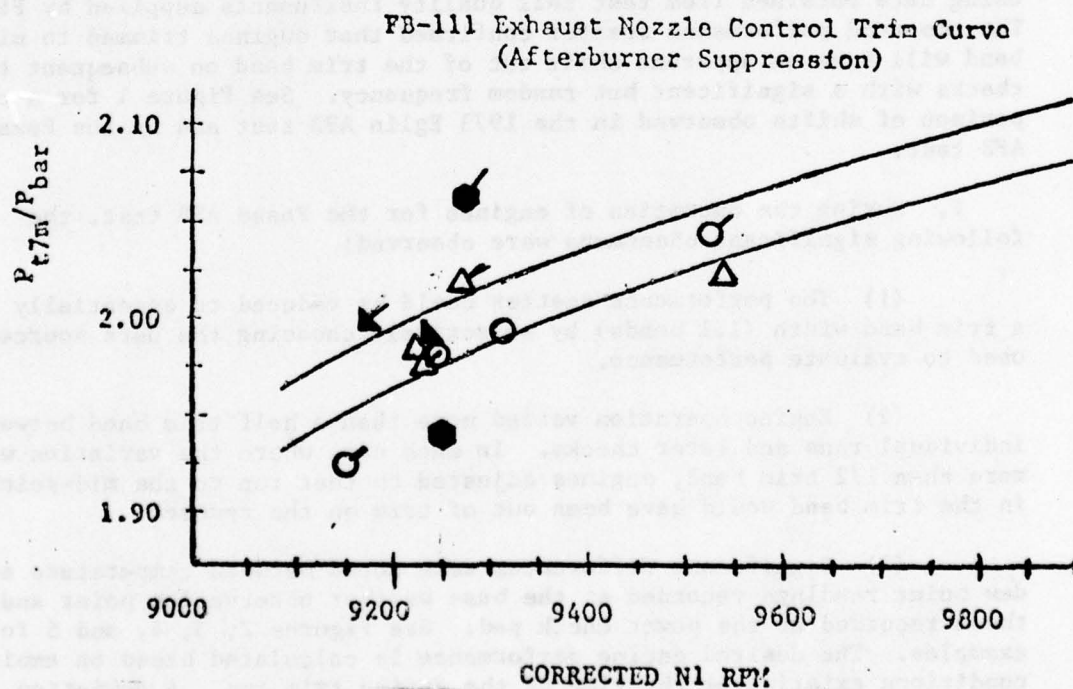
e. The two test engines were operated for the equivalent of 55 individual trim runs without adjusting the fuel controls. Engine performance scattered essentially over the trim band tolerance when evaluated using data obtained from test cell quality instruments supplied by P&WA. The observed performance scatter confirmed that engines trimmed to mid-band will have an apparent shift out of the trim band on subsequent trim checks with a significant but random frequency. See Figure 1 for a comparison of shifts observed in the 1973 Eglin AFB test and in the Pease AFB test.

Figure 1 -- Comparison of FB-111A observed engine performance from April 1973 Eglin AFB trim test and from September 1974 Pease AFB trim test.

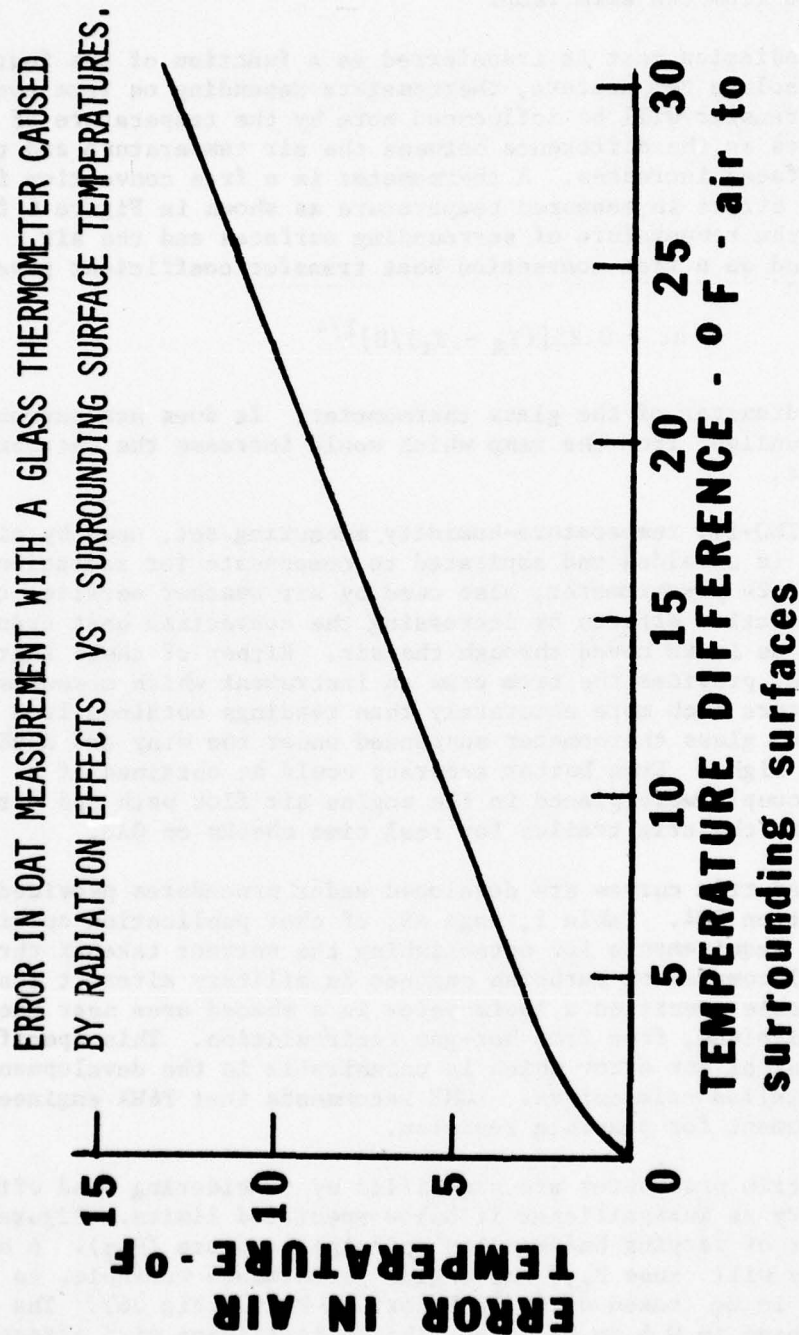
e. Outside air temperature instrumentation specified by P&WA instructions 504 for development of installed trim curves is subject to significant errors from direct radiation and reflected solar energy. (The instructions specify a $\pm 1^\circ\text{F}$ thermometer hung in a shaded area free from hot gas recirculation near the test stand or airplane.) Errors in the measurement of outside air temperature cause unwanted variation in the developed trim curves.

FIGURE 6. RADIATION EFFECTS ON A GLASS THERMOMETER HUNG IN THE SHADE FOR THE PURPOSE OF MEASURING AMBIENT AIR TEMPERATURE. REFLECTED SOLAR ENERGY IS ASSUMED TO BE ZERO. NATURAL CONVECTIVE HEAT TRANSFER COEFFICIENT IS OBTAINED FROM $H_c = 0.25 [(T_{\text{thermometer}} - T_{\text{air}})/DIA]^{1/4}$

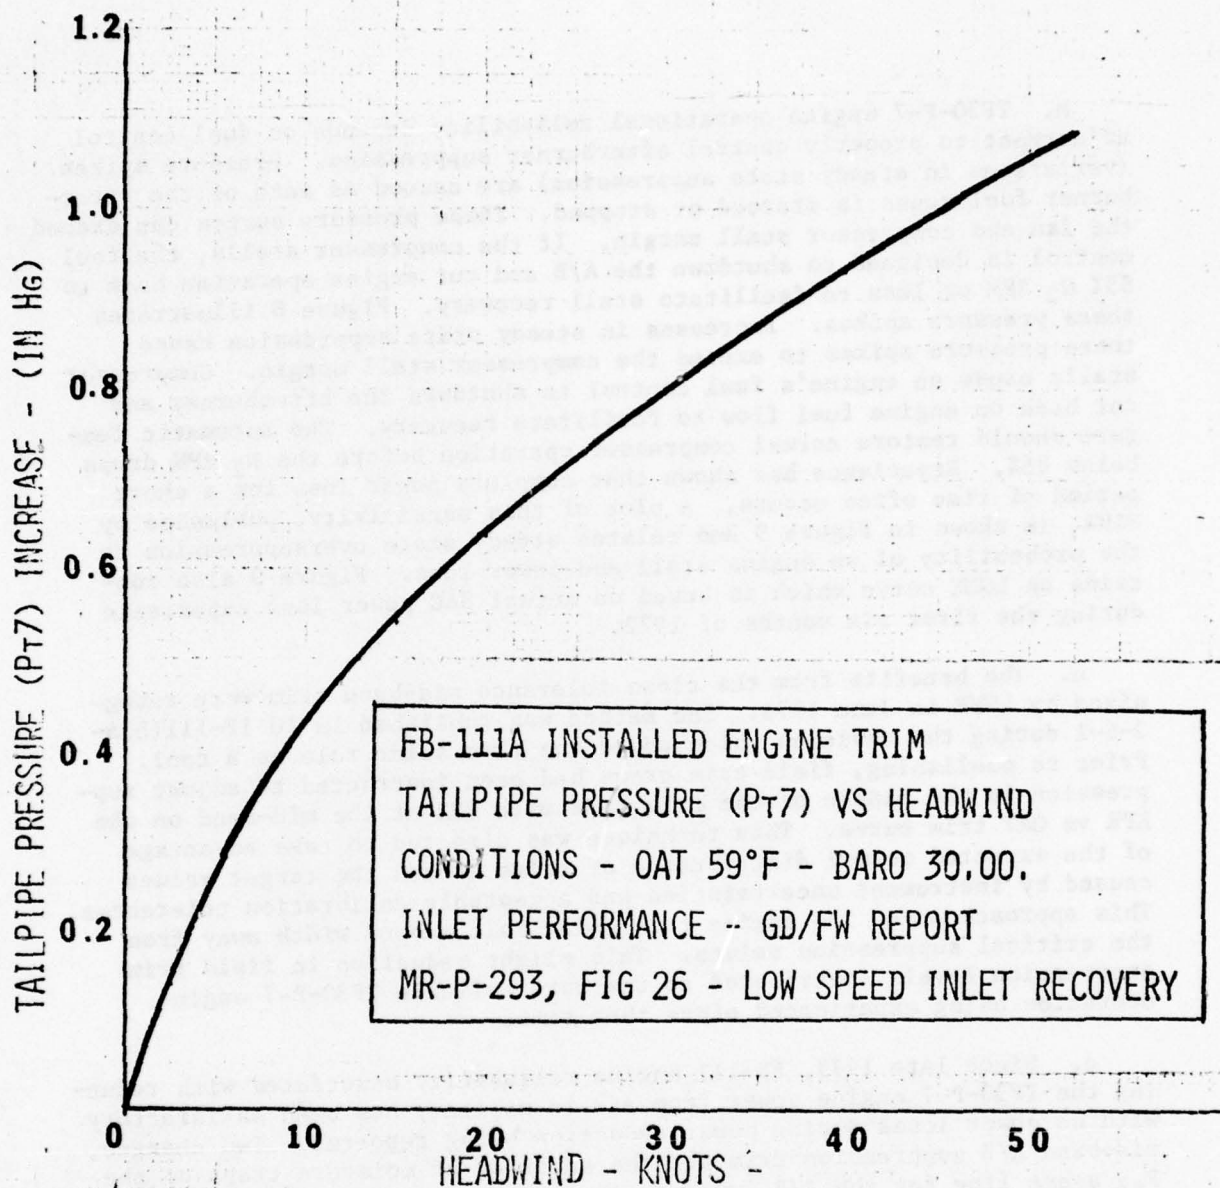
FIGURE 7

l. Engine trim procedures are simplified by considering wind effect on inlet recovery as insignificant if below specified limits. Figure 7 shows the effect of varying headwind on tailpipe pressure (P_{t7}). A headwind of 15 knots will cause P_{t7} , the engine performance variable, to increase by 0.5 in Hg (based on GD/FW Report MR-P-293, Fig 26). The allowable trim band in 0.5 in Hg wide. The insignificant wind effect assumption is necessary to provide an acceptable maintenance procedure and is justified by the fact that it produces an undertrim. Cross wind effects, however, can cause decreases in inlet recovery which, theoretically, will cause overtrims. The relative effects of crosswind on inlet recovery are presently undefined.

A Trimshift of one band width will be apparent between zero wind and 15K headwind conditions. Current trim procedures are simplified by assuming that wind effects are negligible and can, therefore, be neglected. This curve shows the change in tailpipe pressure in inches of mercury that headwinds will cause. The effect of crosswinds on inlet recovery is not presently defined.

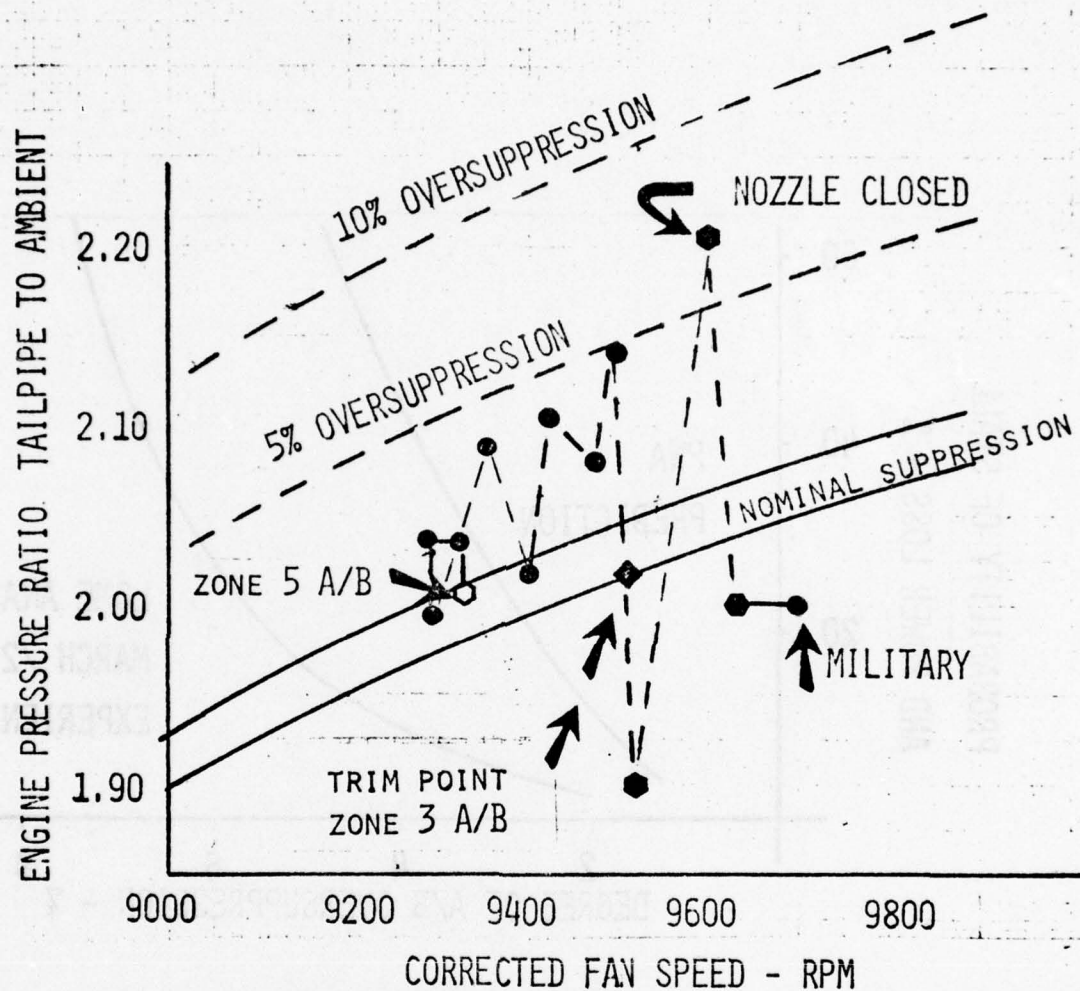
FIGURE 8. EPR and RPM dynamics during snap throttle retard from maximum A/B to military power for a TF30-P-7 engine trimmed to the bottom of the suppression band.

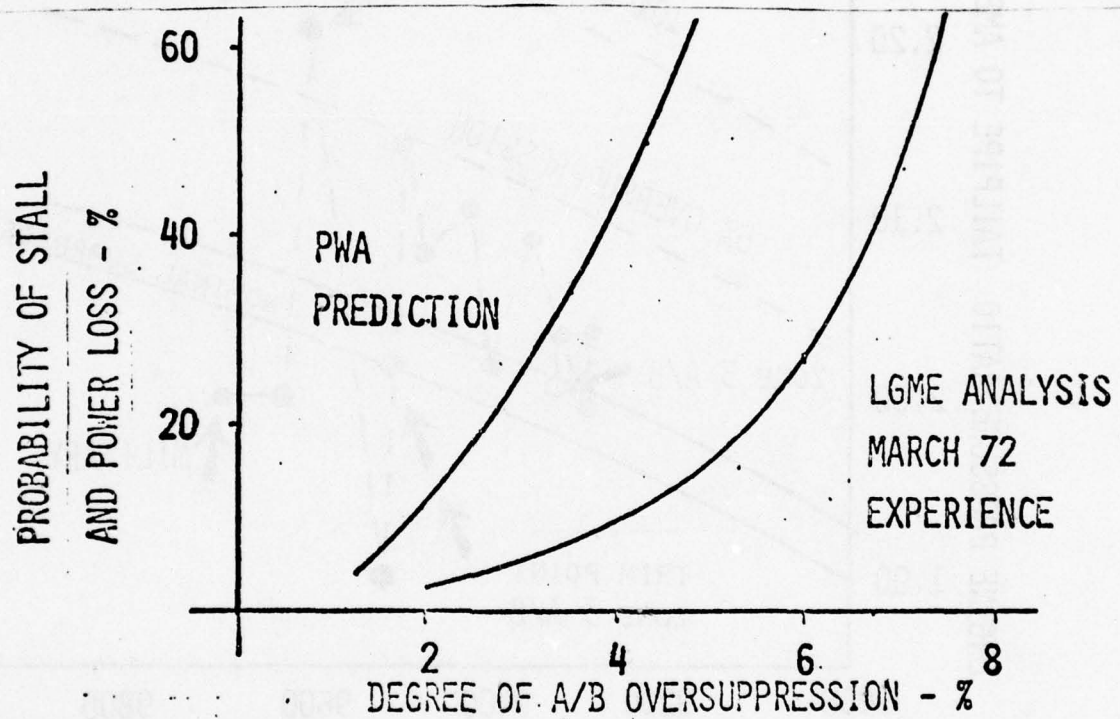
Figure 9. Comparison of power loss probability associated with the degree of A/B oversuppression predicted by P&WA and SAC FB-111A experience during the winter of 1971 - 1972.

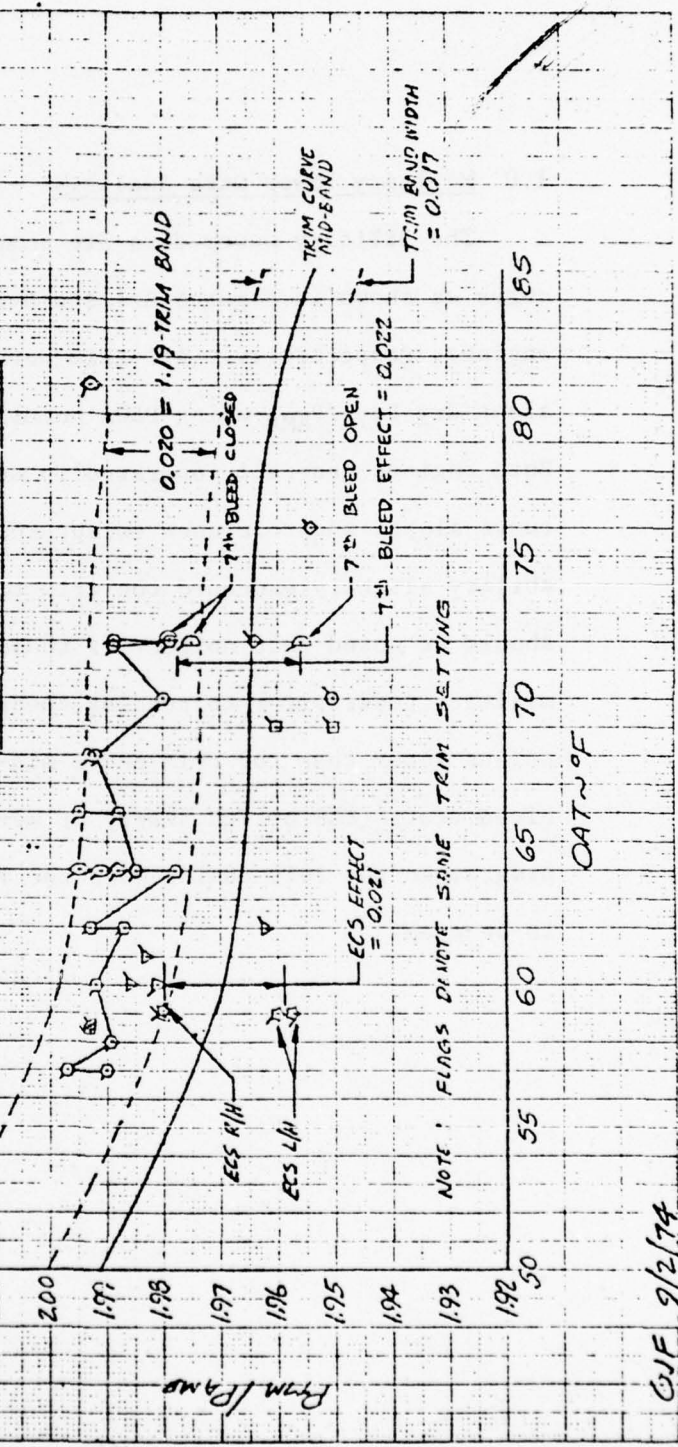
FIGURE B-1
MILITARY POWER TRIM SUMMARY
TF30-P7 TRIM TESTS PERSE AFB
LYH ENGINE

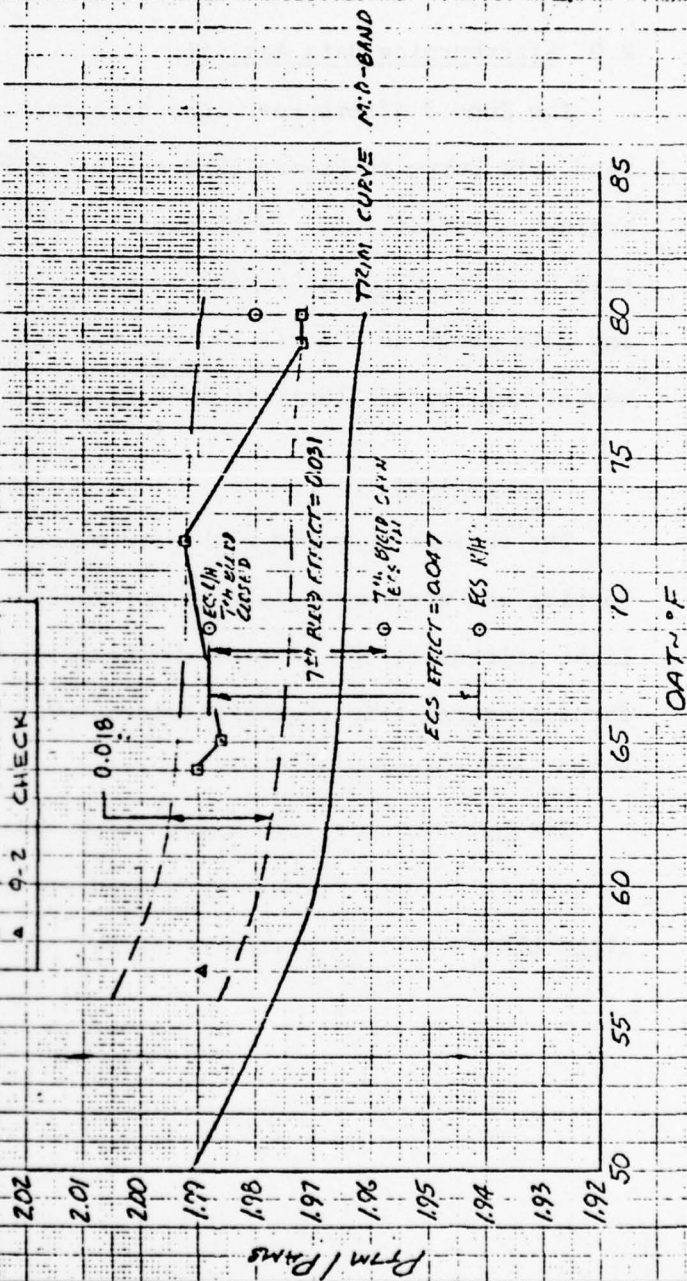
FIGURE B-2
MILITARY POWER TRIM SUMMARY
TF30-P-7 TRIM TESTS AT CRASH AFB
C-1A ENGINE
